PUMP INSPECTION REPORT

Inspection Date: **JANUARY 7-8, 2010**

Customer Description: **#3 WEST MIXED FLOW WATER CIRC PUMP**

Manufacturer: **FOSTER WHEELER CORPORATION**

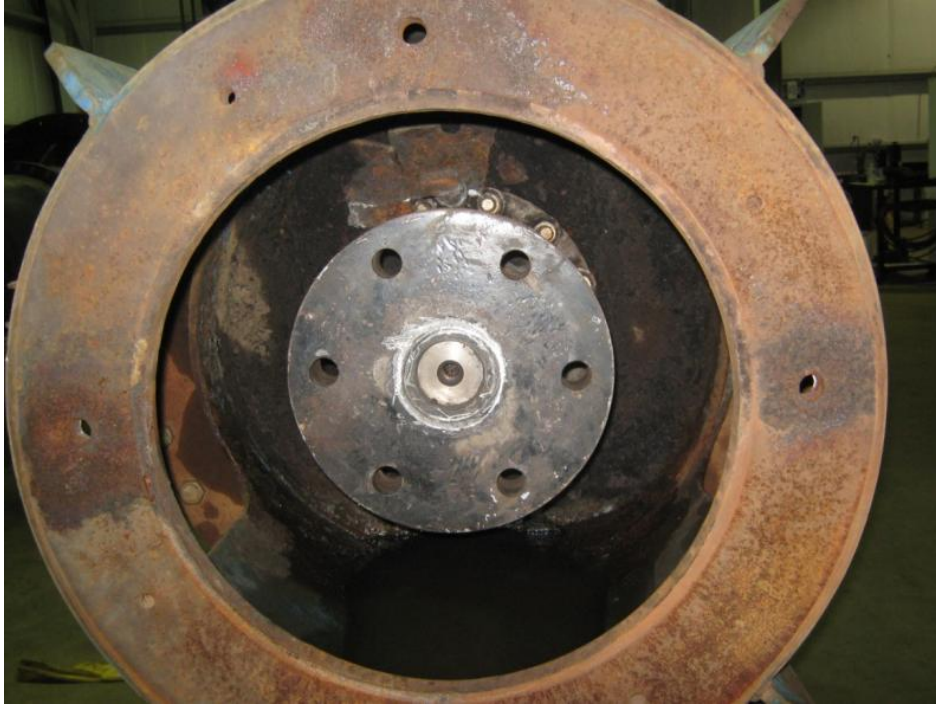
1. Pump Half Coupling (Item 05) – Inspected & OK

a. Key and Keyway - OK

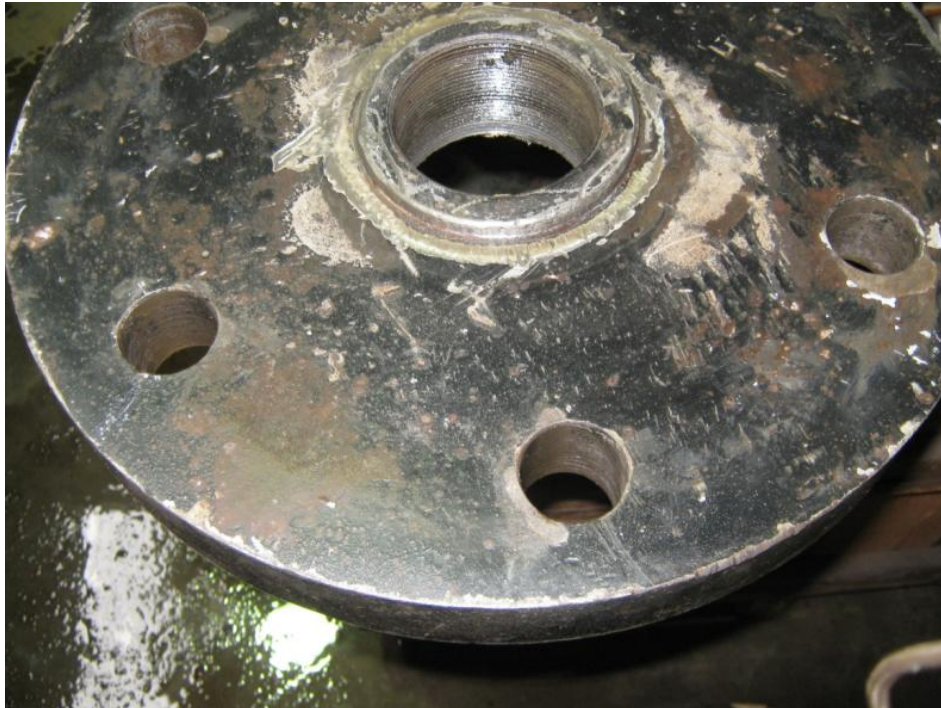
b. Coupling Threads – Inspected & OK. Coupling Inner Bore = 3.875”.

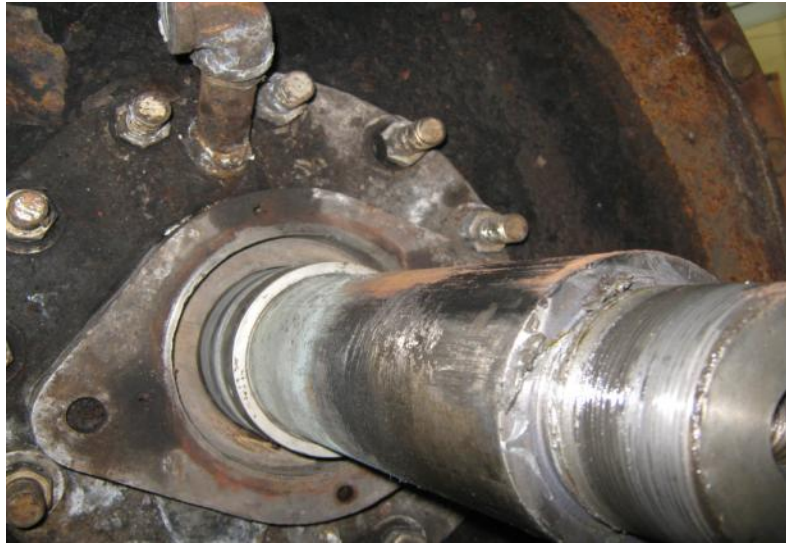
2. Upper Shaft (Item 01) @ Motor/Pump Coupling

- a. Coupling Threads – Inspected & OK.

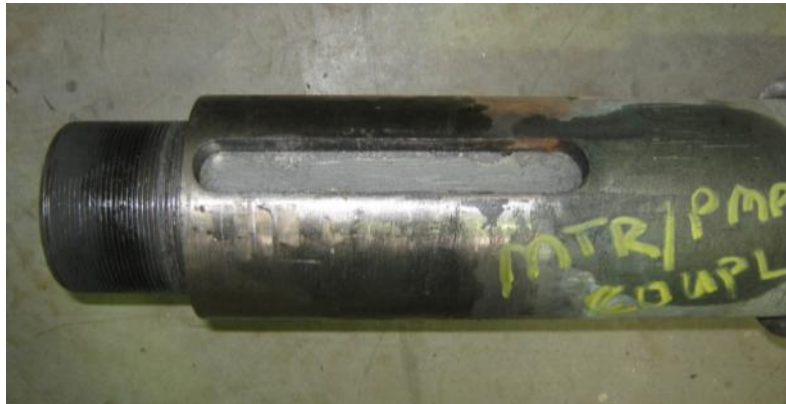
- b. Motor/Pump Coupling Key (Item 06) – Inspected/OK.
Shaft Diam. = 3.873”.

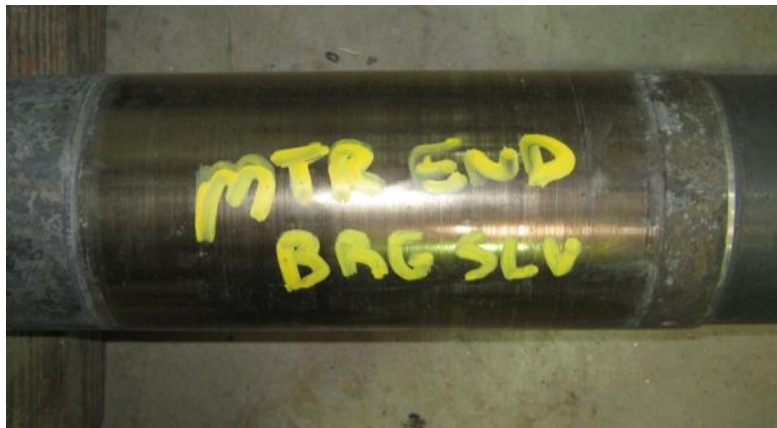
- c. Upper Shaft Bearing Sleeve – Inspected, Polish & Reuse,

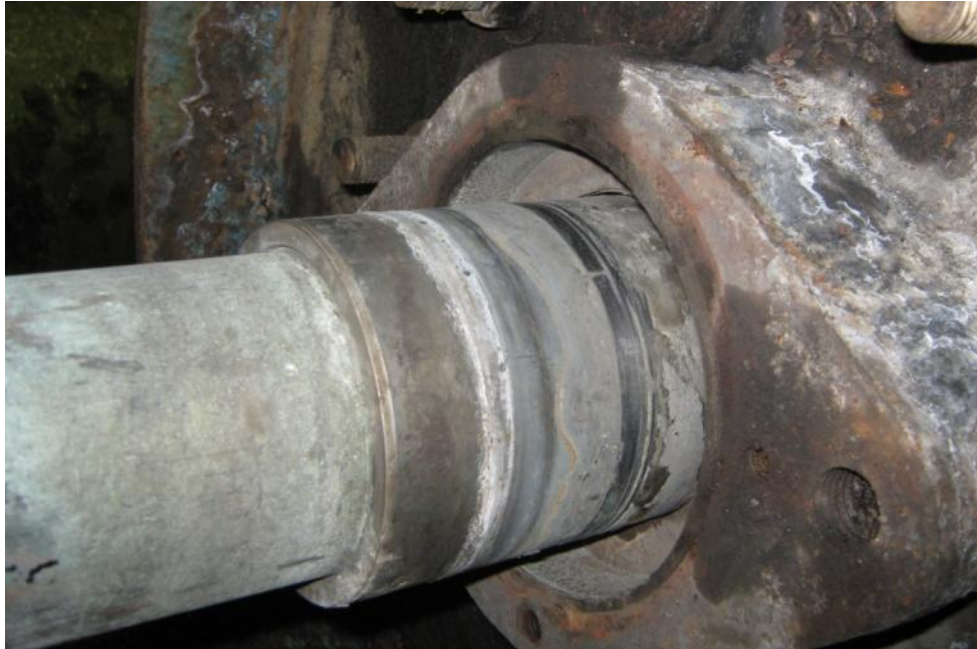
3. Stuffing Box (Item 56) and Upper Bearing Assembly

- a. Mechanical Seal to be provided and installed.

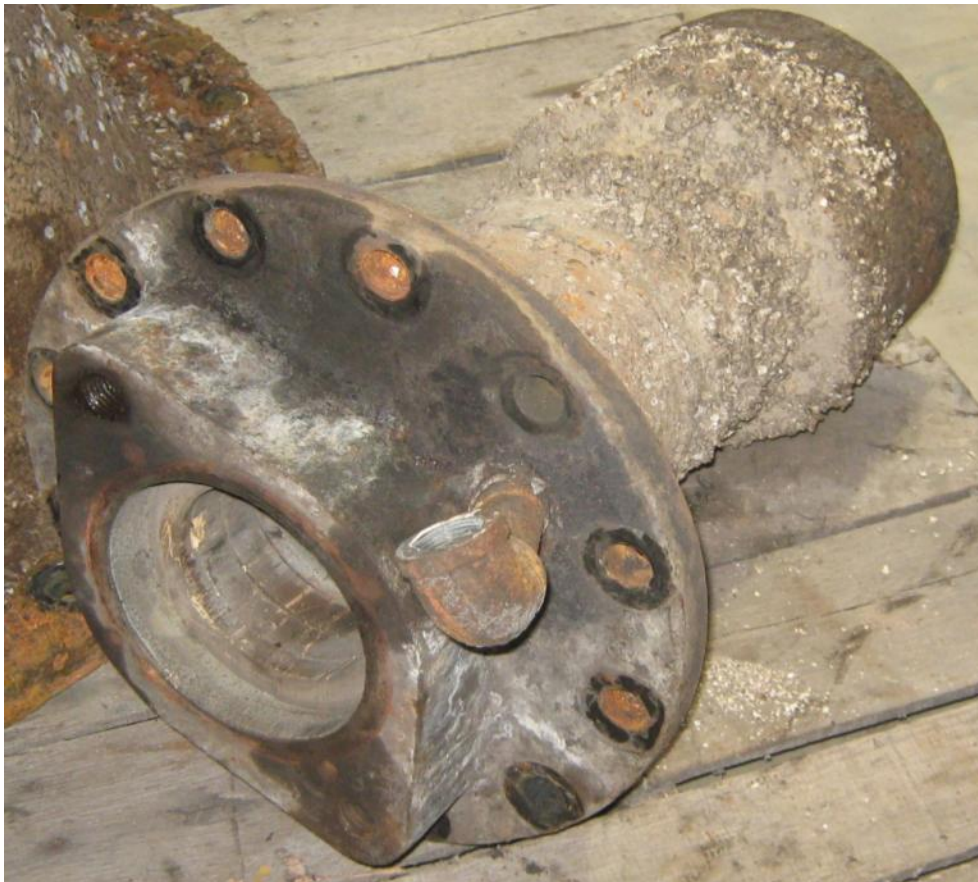
- b. Stuffing Box Throttle Bushing - Inspected & OK. Polish/Reuse.

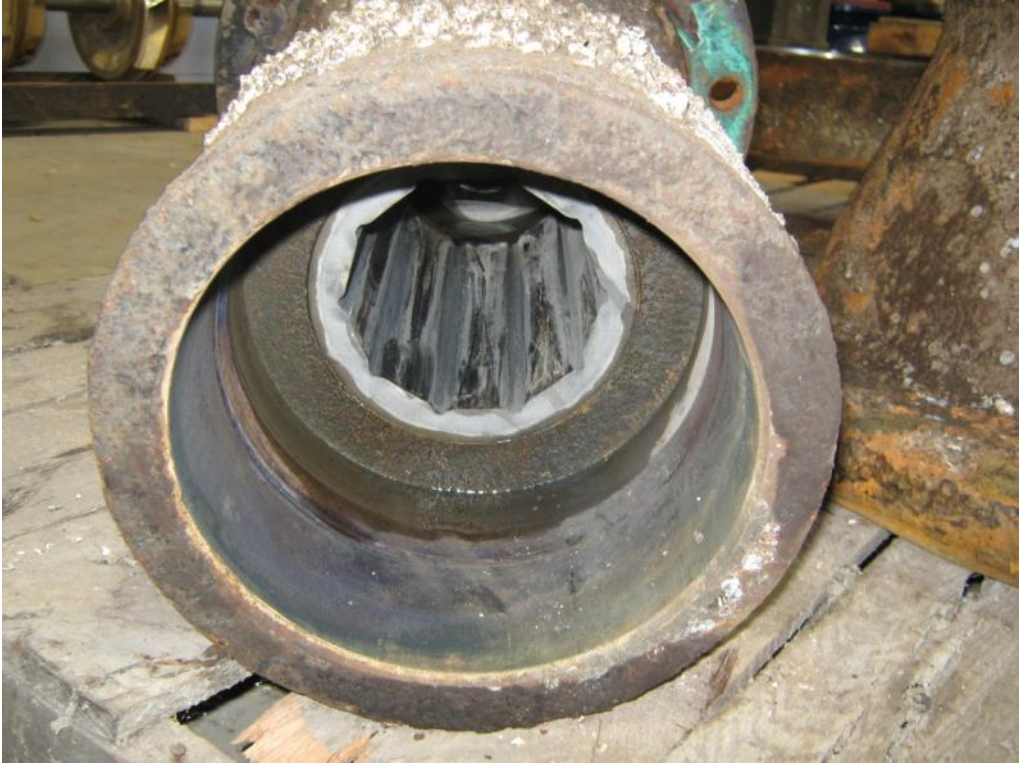
c. Stuff Box Bearing (Item 70) Worn/Replace. Bearing OD/Housing ID =6.122”

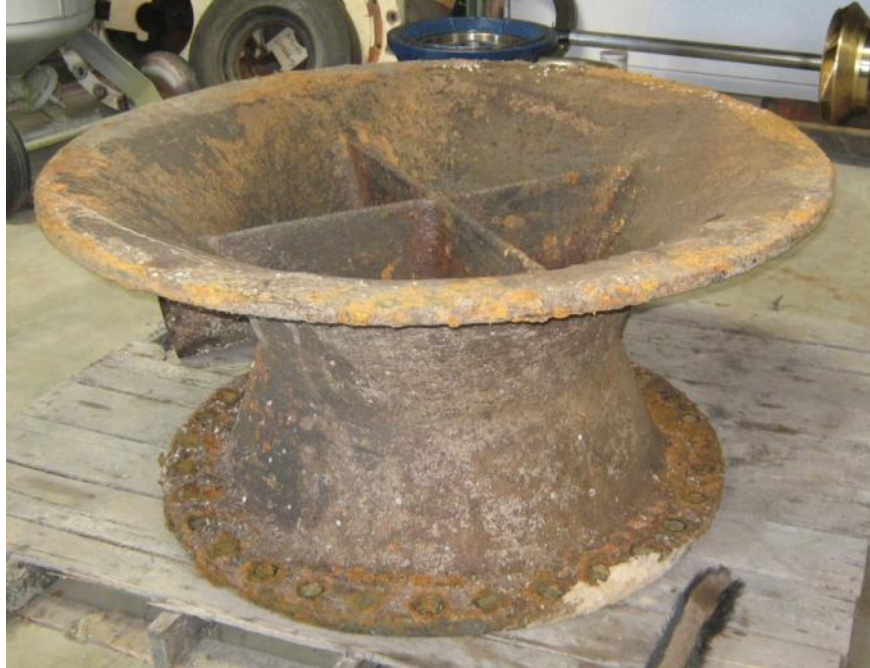
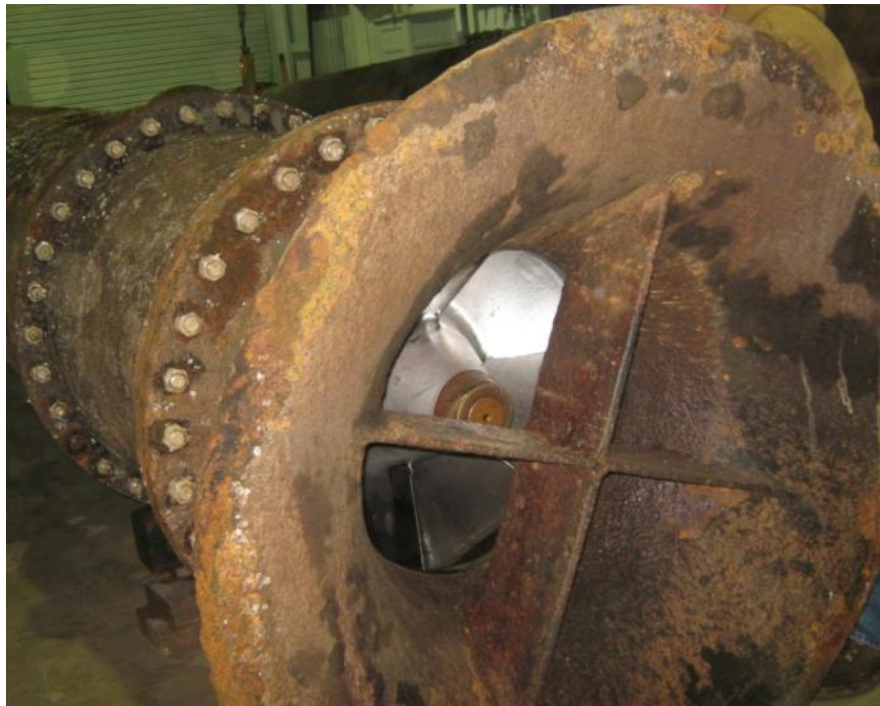
4. Suction Piece (Item 41) – Inspected & OK. Sandblast Clean, Epoxy Recoat.

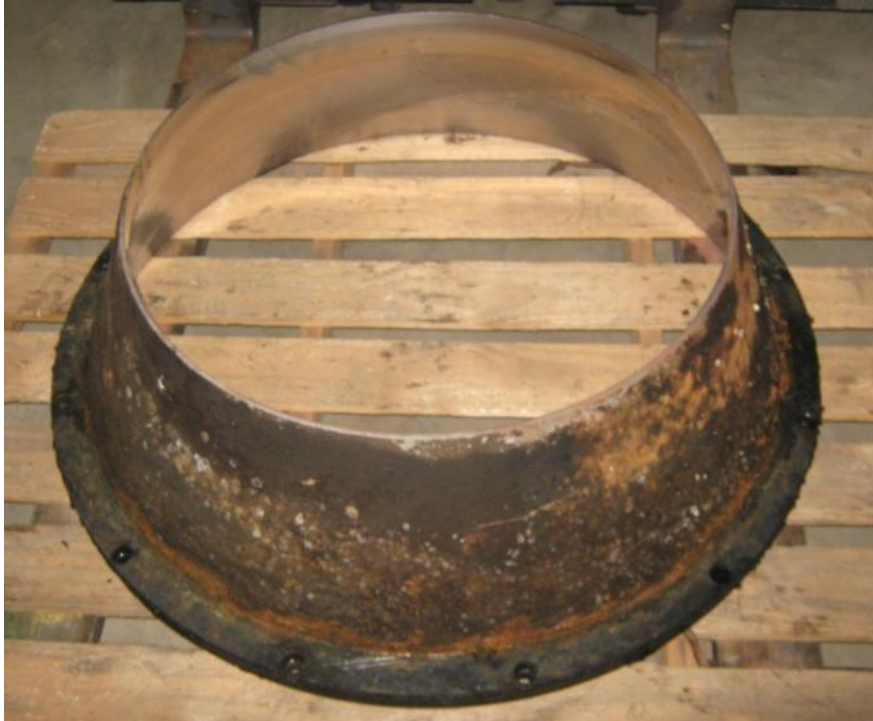
5. **Impeller Shroud Ring (Item 80)** – Inspected & OK. Sandblast Clean.

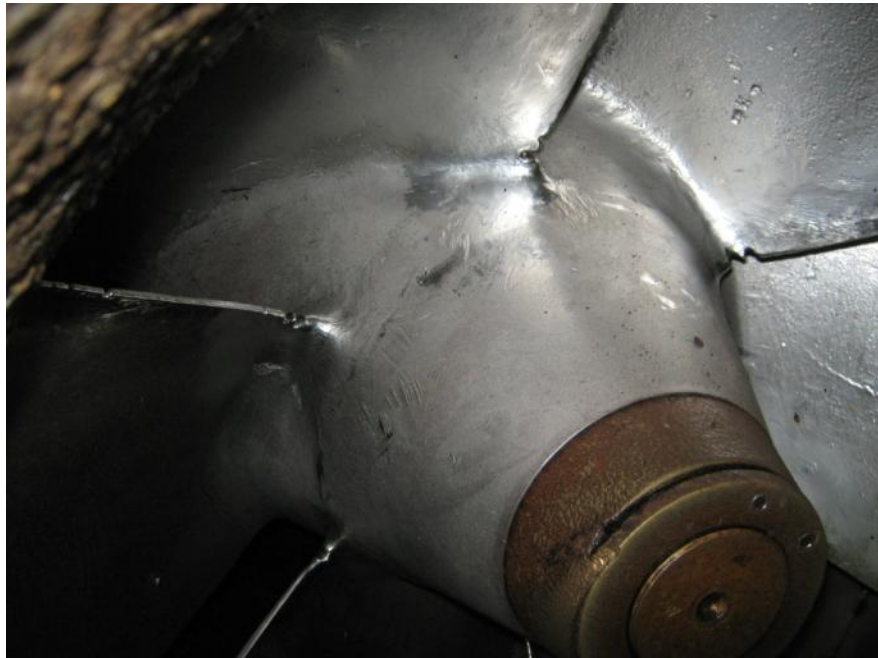
6. **Impeller (Item 31)** – Minor wear/damage leading edge. Weld Repair/NDT/Dye Penetrant.

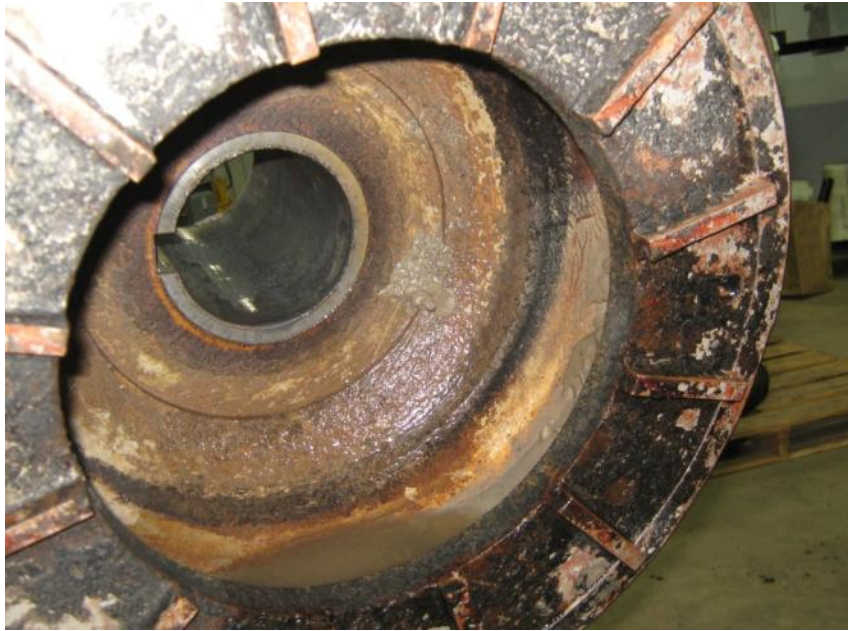
7. **Impeller (Item31) Bore/Fit** – Inspected/OK. ID/Bore = **3.875”**.

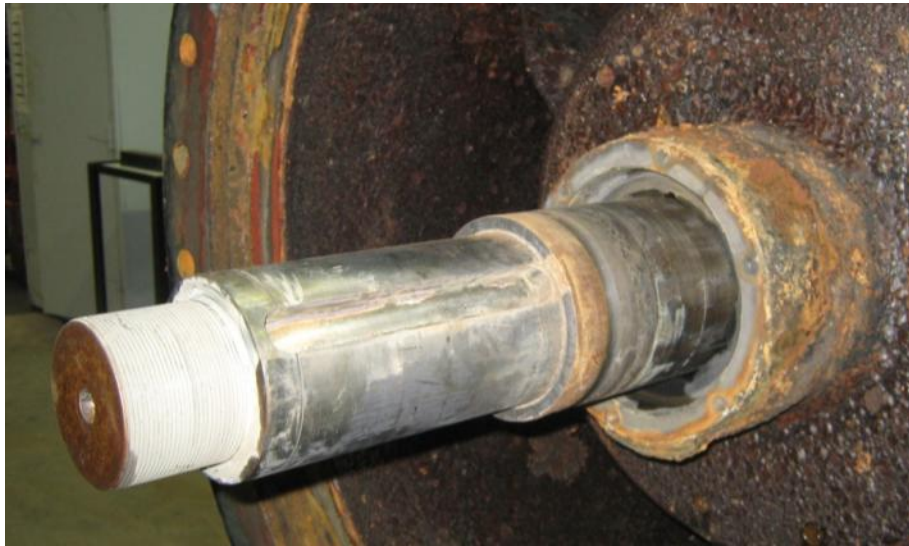
8. **Lower Shaft (Item 02) @ Impeller**– Inspected/OK.
Impeller Keyway & Cap Threads OK. Shaft Diameter = **3.873”**.

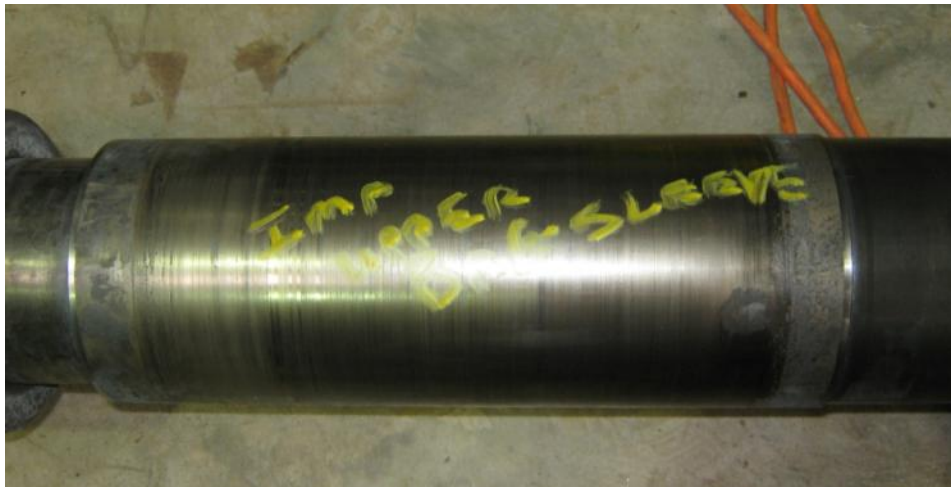
9. **Lower Shaft Upper Bearing Sleeve** - Inspected/OK. Polish & Reuse.

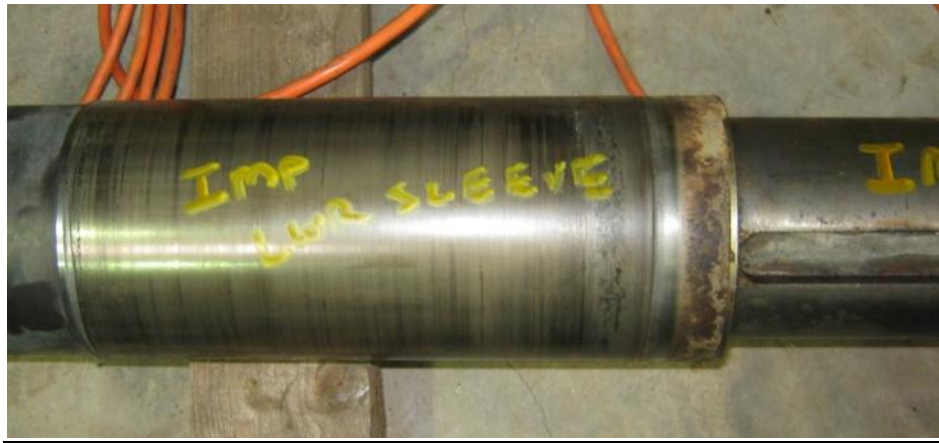
10. Lower Shaft Lower Bearing Sleeve – Inspected/OK. Polish & Reuse.

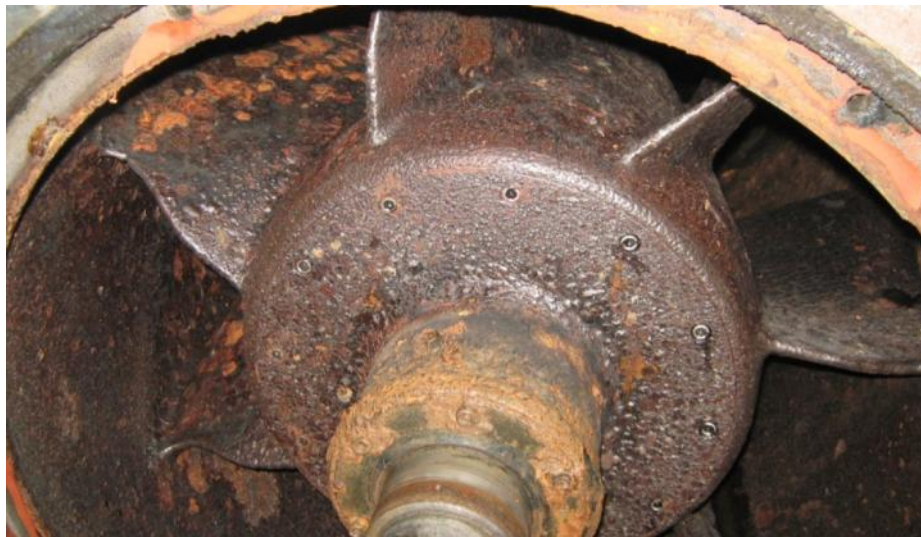
11. Casing Guide Vane (Item 31) – Guide Vanes Inspected and OK.

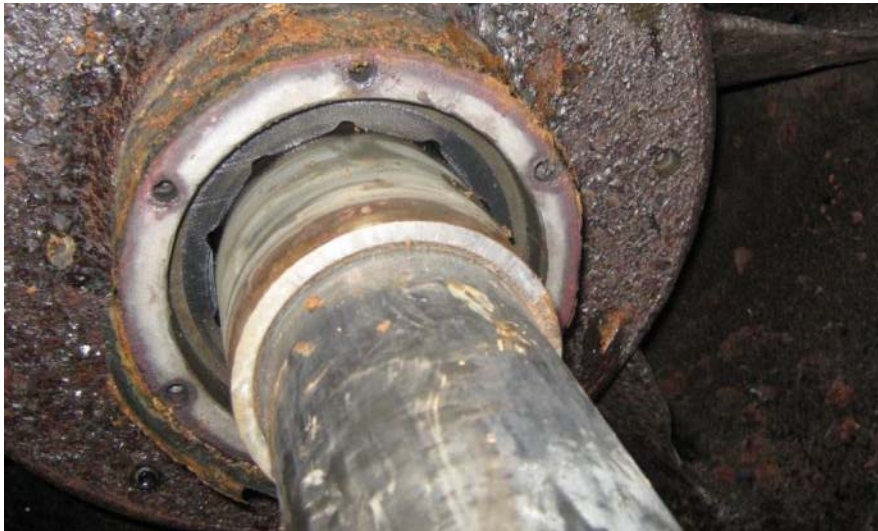
12. Casing Guide Vane Bearing Assembly

- a. Upper Bearing (Item 70) – Worn. Replace. Bearing OD/Housing ID = **6.122"**.
- b. Lower Bearing (Item 70) – Worn Replace. Bearing OD/Housing ID = **6.125"**.
- c. Guide Vane Shaft Seal (Item 82) – Replace.

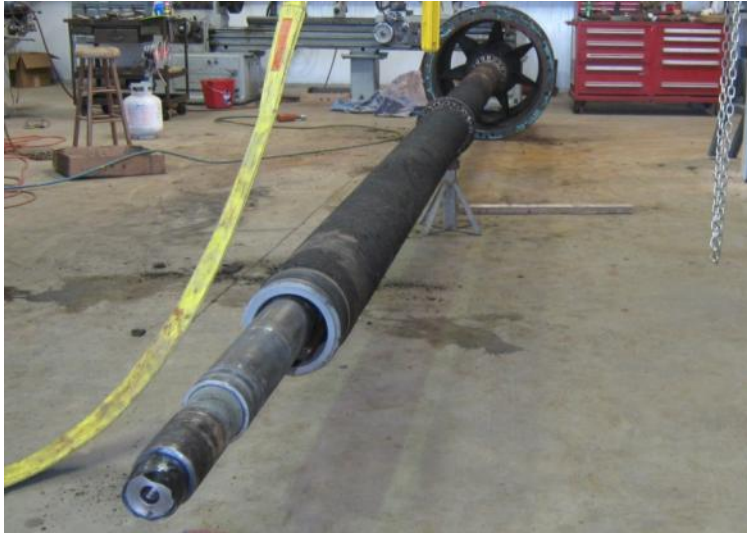
13. Upper (Item 63) and Lower (Item 65) Shaft Enveloping Tubes – Inspected & OK.

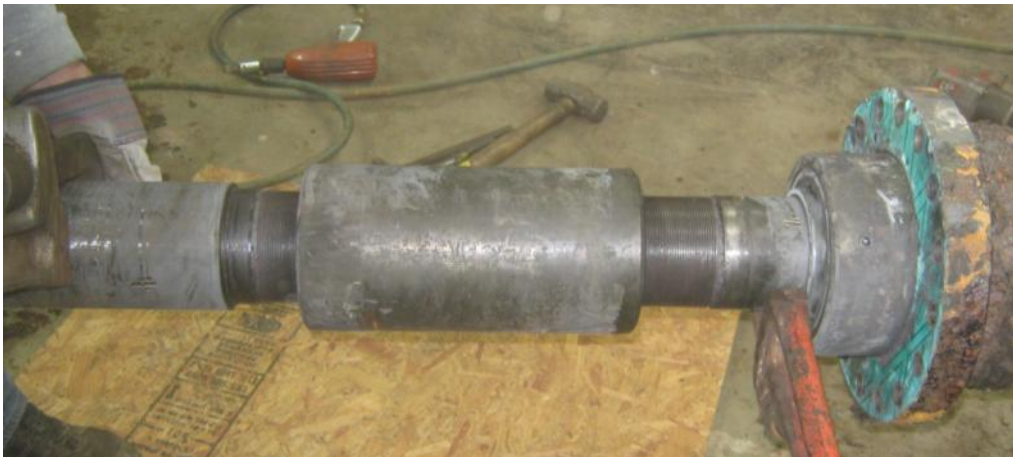
14. Intermediate Shaft Coupling @ Intermediate Bearing

Lower Enveloping Tube Bearing Worn – Replace. Bearing OD/Housing ID = 6.121”.

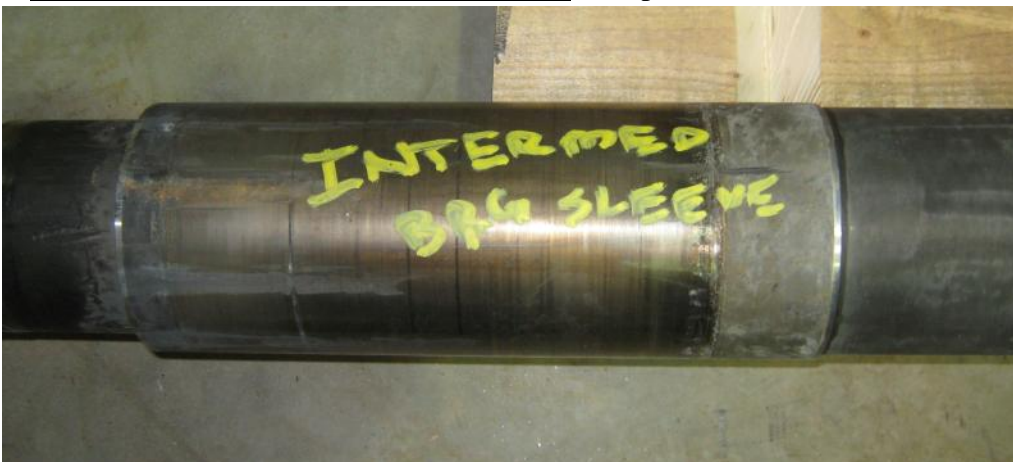
15. Lower Enveloping Tube Bearing Sleeve – Inspected/OK. Polish and Reuse.
